# **Netcare Unitas**

Date: 11/02/2016

Document relates to an: Investigation into water quality, chemical buildup and biological concerns at Unitas hospital.

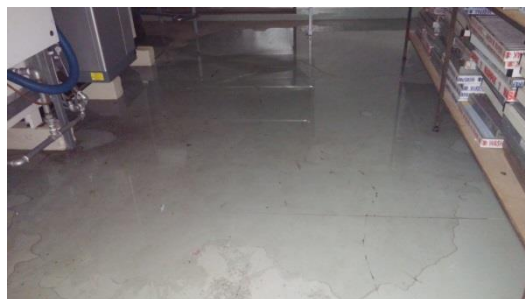
Part of the Burger Radiologist upgrade included a new air handling unit. Less than a year after the installation our plant room was flooded. The cause of this had been calcification inside the humidifier causing obstruction to the drain valve causing seepage which the drain could not accommodate thus flooding the plant room.

During the investigation by Luft technik they took photos of our air handling units humidifier tanks to indicate that it was water and hospital related.

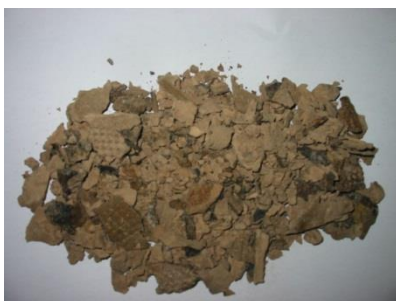
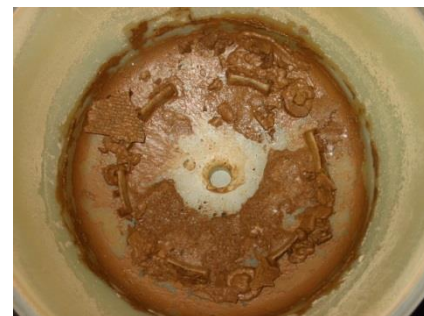
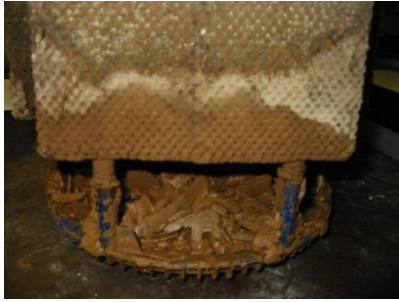
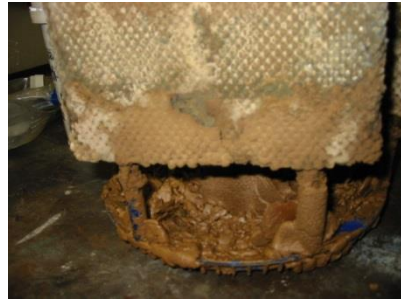
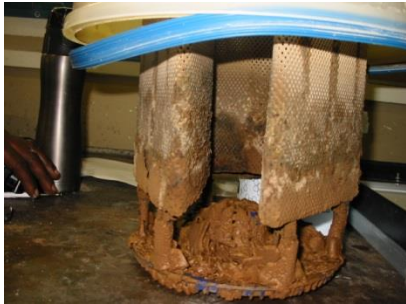
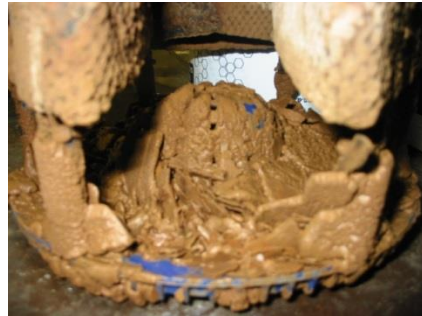
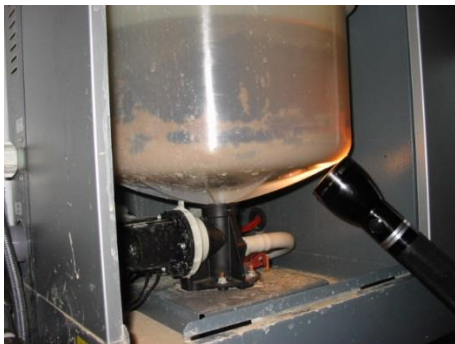
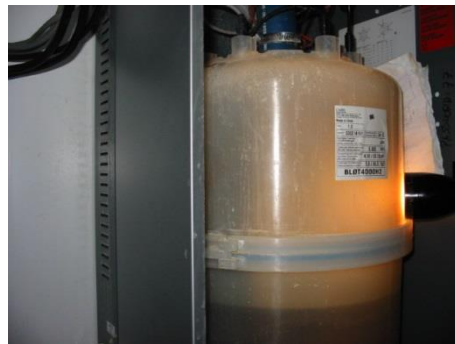
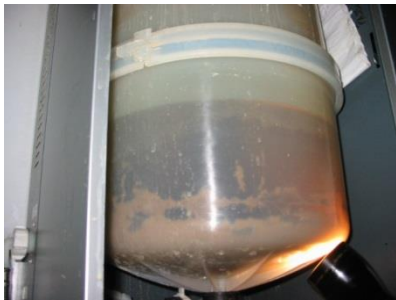
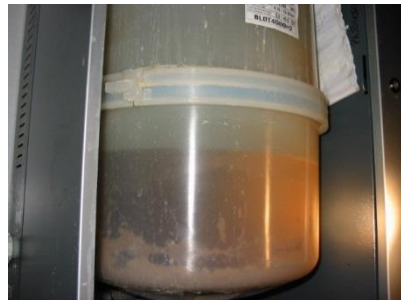
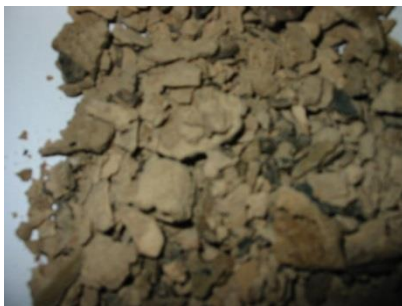
We opened the humidifier for the radiology unit and took photos.

The calcification was clearly visible. The “scale” and debris in the container was hard and did not disintegrate when dried out. Note: humidifiers only fill when humidification is required varying the amount of water exposed to the element for steam generation. Once humidification is reached and stabilized “dumps” the excess water and fills again when required.

There is no real manual intervention which can be applied. Only other option would be to disengage the humidification but that would contradict the operation.

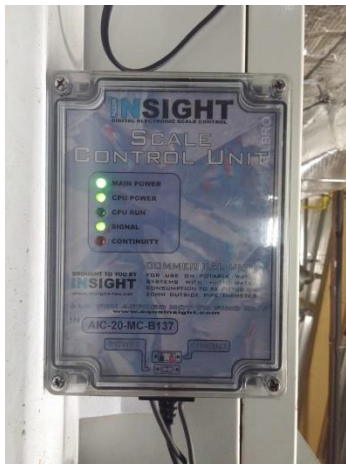
Theater 18's unit installed

A hospital request to isolate the “theater 18’s” autoclave, offered a “solution” to the problem and a way to confirm our opinion about the affectivity of the electronic scale control. We installed the autoclaves unit on the humidifier in question. Unit is suitable to a pipe size of 20mm outside diameter.

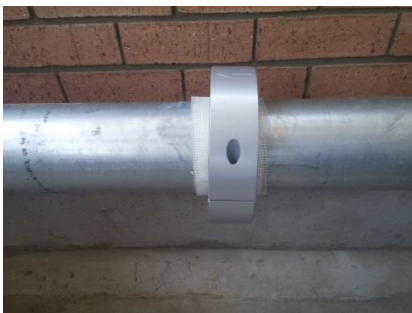
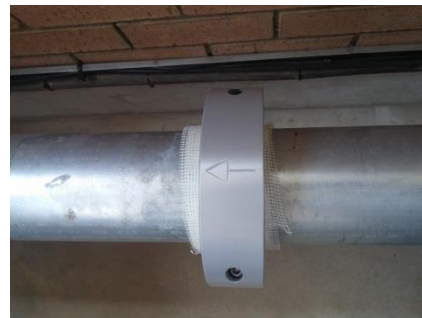
We commissioned the bulk water storage container on the 4<sup>th</sup> December 2015. Wellan representative came to site and did their installation on the 8<sup>th</sup> December 2015. I was present and it took 8 minutes to install the ring.

After the installation we stopped (switched off) the electronic scale control units in the hospital supplying water to the CSSD and the Radiology department.

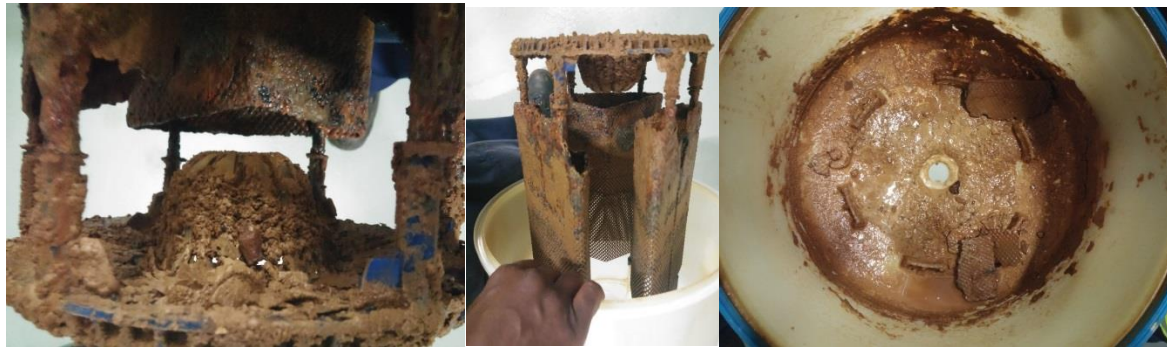
We opened the humidifier of the Radiology department to do a visual investigation and although not in the hot water line it was in the same vicinity as the other effected pipes.

We already noted an improvement. Due to the extent of the trail and the fact that I want to see the result in the boilers of the autoclaves (We removed approximately 2 Kg worth of hard scale from every boiler during very service) I had requested our handyman which does the blow downs on the autoclave boilers to suspend that operation so that we might collect and measure the buildup. We had to replace a discharge valve, due to the fact that the remaining material in the boiler is much finer in texture it now moves easier but also creating a grinding media wearing the seating in the valves. Where high volume, pressure release takes place the “damage” prevents the valve from closing properly. Due to this we will start regular blow downs again so that the bulk can be flushed by means of a manual valve.

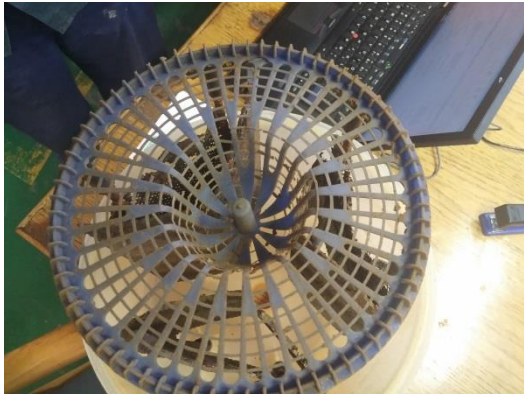
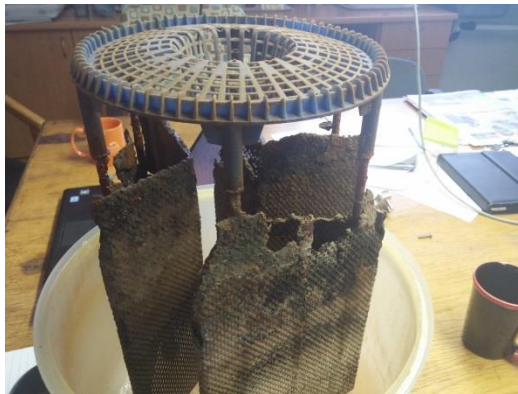
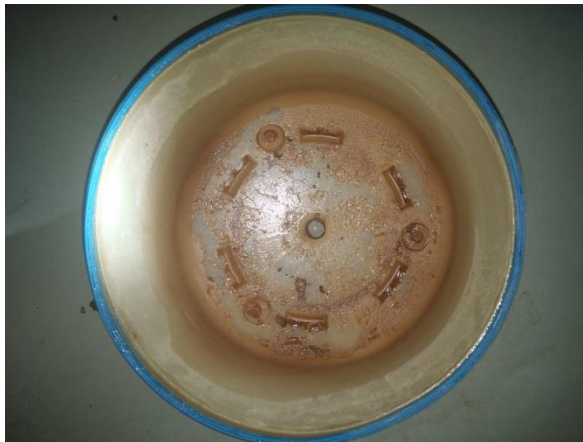
As the trail was drawing to a close we opened the humidifier of the radiology unit to do a visual inspection.

The results speak for themselves. It also became apparent the amount of damage that is being caused by the calcification as well as the corrosive action to the elements. I had also taken photos of the humidifier tanks in the plant room as comparison to the previous ones that had been taken by Luft Technic.

Please note that theater 1 we are waiting for a humidity sensor, Trauma and casualty units hardly ever work (due to demand) and theater 8 Pc board is faulty and theater 11's tank need to be replaced. The condition of the remaining humidifier tanks theater 2, 3,4,5,6, and 7 are functioning. The discoloration of the tanks is gone as well as the residual marks from previous calcification buildups.

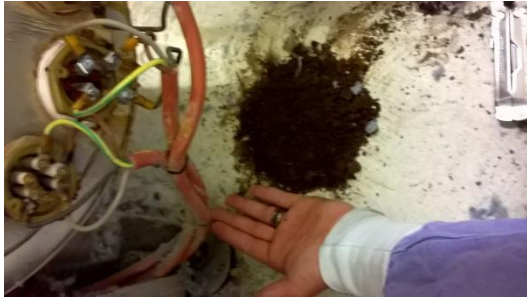
The amount Residue

We opened autoclave no 3 to investigate.

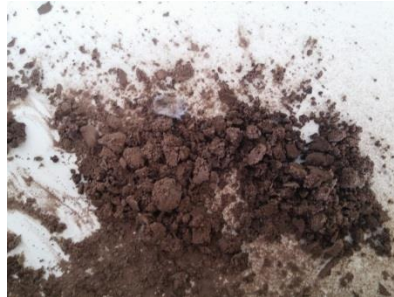
Residue soft in nature and exposed to sun dries to powder

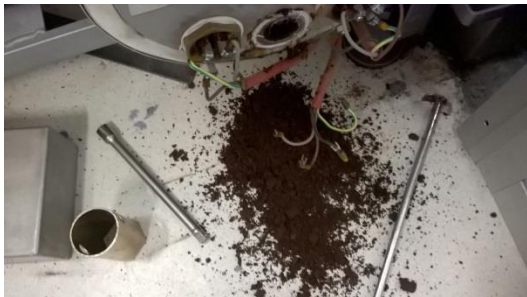
Residue removed

The residue on the elements was soft and we wiped it off with a rag. Once drier we used compressed air to remove the rest of the powder.

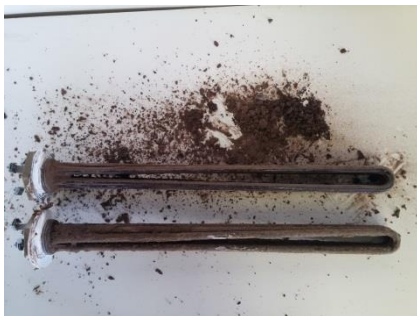
Residue wiped off

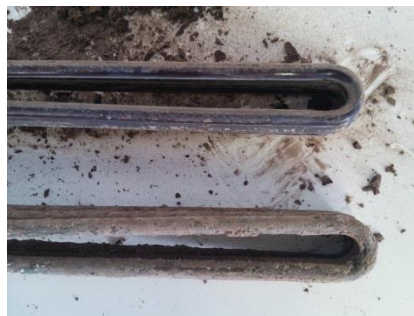
Condition of the element after being wiped down

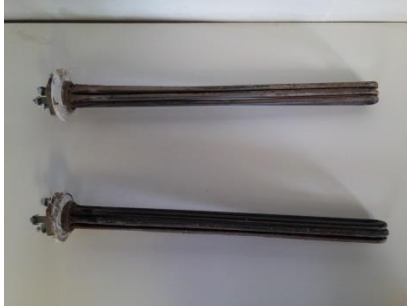
Elements after being dried in the sun and blown down with compressed air.
